Santa Fe River Study

Report on Existing Environmental Conditions
and
Potential Natural Resources
Restoration Projects

5 December 2007

Prepared by
John S. Pittenger and Karen A. Yori
Blue Earth Ecological Consultants, Inc.
1345 Pacheco Street
Santa Fe, New Mexico 87505

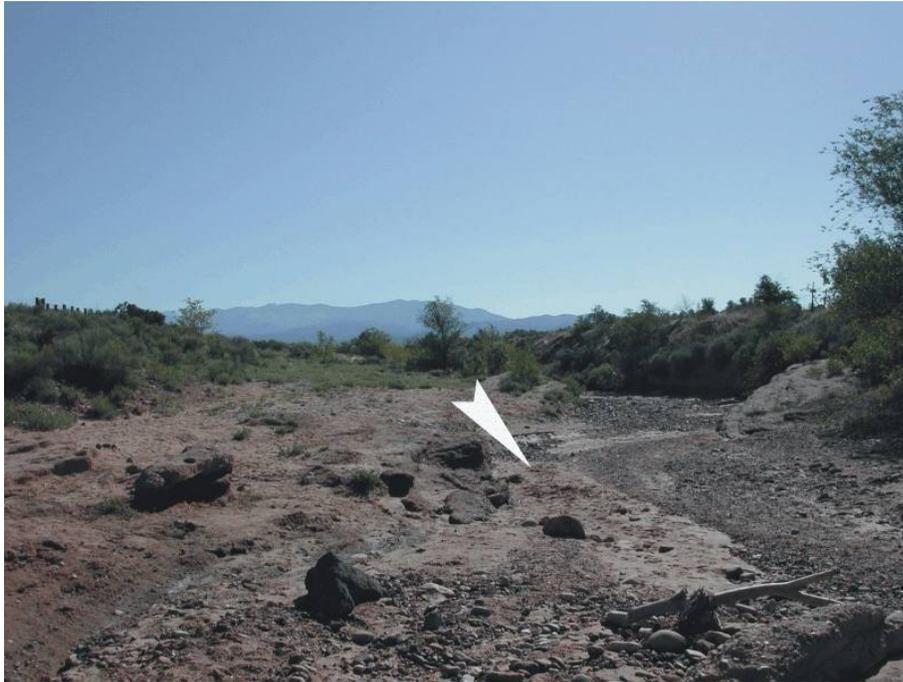
The Cieneguita Spring (Figure 8) and Agua Fria Spring sites on the Santa Fe River no longer have surface water except during periods of rainfall runoff, due to lowering of groundwater levels by groundwater withdrawal from municipal wells, reduced stream flow, and cessation of irrigation. Currently, groundwater in the Tesuque Formation is well below the surface in the study area (McAda and Wasiolek, 1988: 23) and therefore is not likely to influence existing plant growth or ecological function.

Figure 8. View upstream of the Cieneguita Spring site at present-day Frenchy's Park, 26 June 2007. Arrow indicates outcropping of compact, red conglomeratic silts of the Tesuque Formation (photo by J. Pittenger).

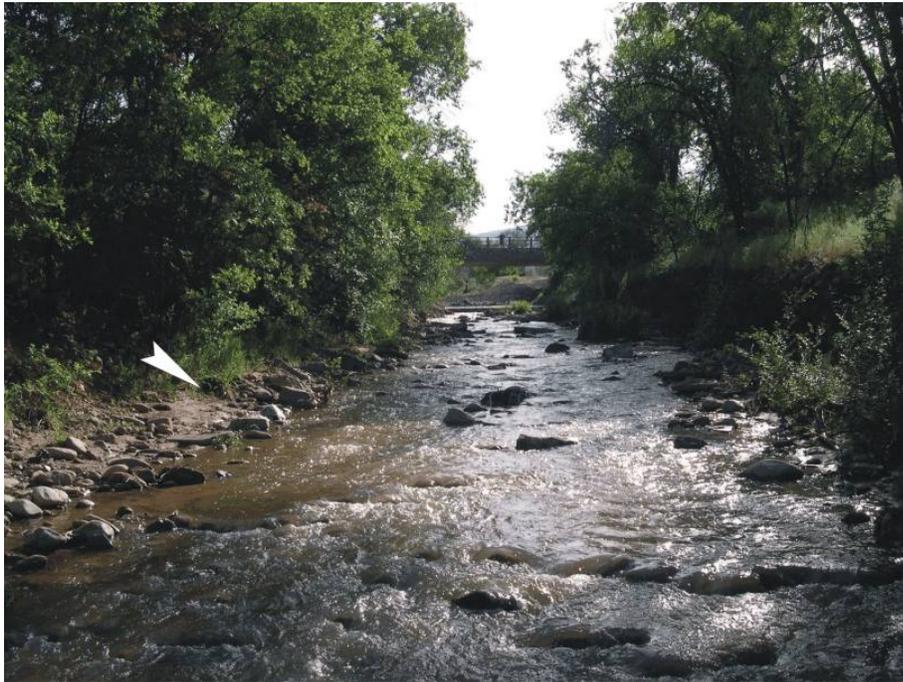
The B stream type is moderately entrenched with moderate bankfull width-to-depth ration and a relatively steep gradient (2 to 4 percent). The B-type channel in the study area has a bed dominated by gravel with some sand and cobbles. In the study area, the B4 stream segment is bounded on the downstream end by a grade control structure. This stream type was delineated in segment SFR-1, which is a 1,767-foot reach downstream from Camino Alire (Figure 11). Gabion basket walls line portions of the banks in this reach. Degradation is not occurring in the B-type channel segment in the study area. Furthermore, rapid channel widening is not occurring, as evidenced by vegetated banks and absence of raw, vertical cuts (Figure 12). Therefore, following the preceding discussion in

Figure 12. Stream type B4 below Camino Alire bridge. Arrow indicates field determination of bankfull stage. View is upstream, with the bridge in the background. Photo by J. Pittenger, 28 May 2007.

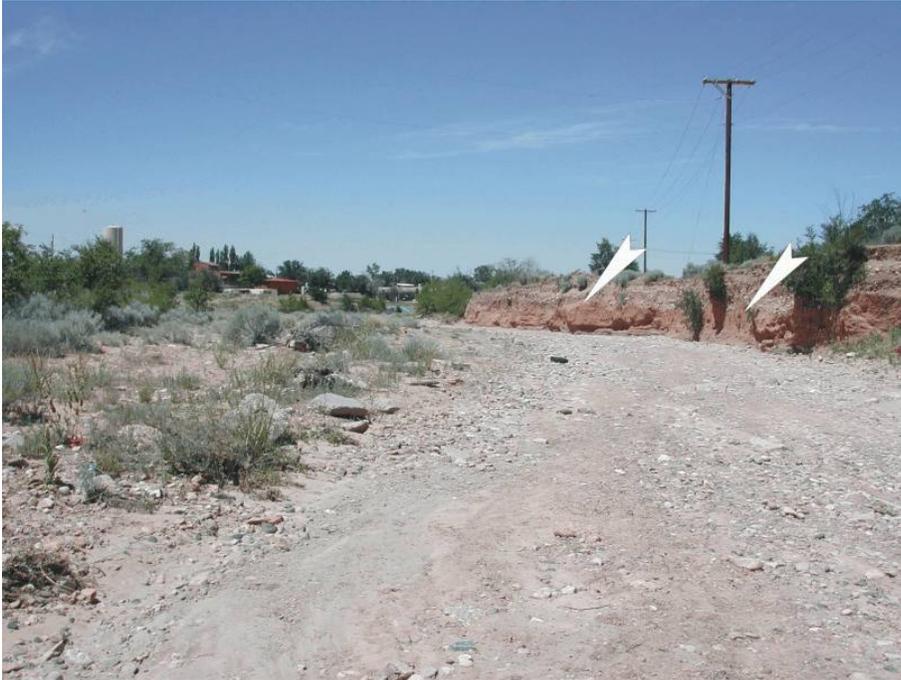
Type III (*i.e.* disequilibrium condition) C-channel reaches are characterized by rapidly eroding, often steep-walled banks. Examples of these are found in segment SFR-12 upstream from the Cottonwood Mobile Home Park and in segment SFR-7 (Figure 16).

Figure 16. Type III (disequilibrium) C5 channel. Reach is located in segment SFR-7. Arrows indicate actively eroding bank and zone of rapid channel widening. View is downstream toward the San Ysidro crossing. Photo by J. Pittenger, 26 June 2007.

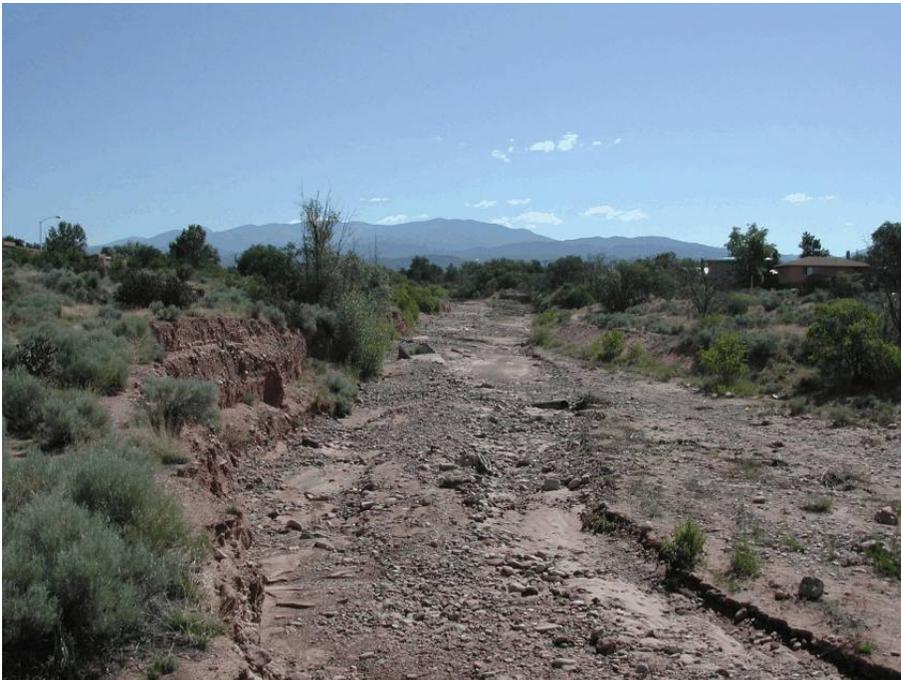
Figure 17. Stream type F4 upstream from Frenchy's Park. Coarse bed material and paucity of aggradation indicate the bed in this reach is still degrading. View is upstream. Photo by J. Pittenger, 15 June 2007.

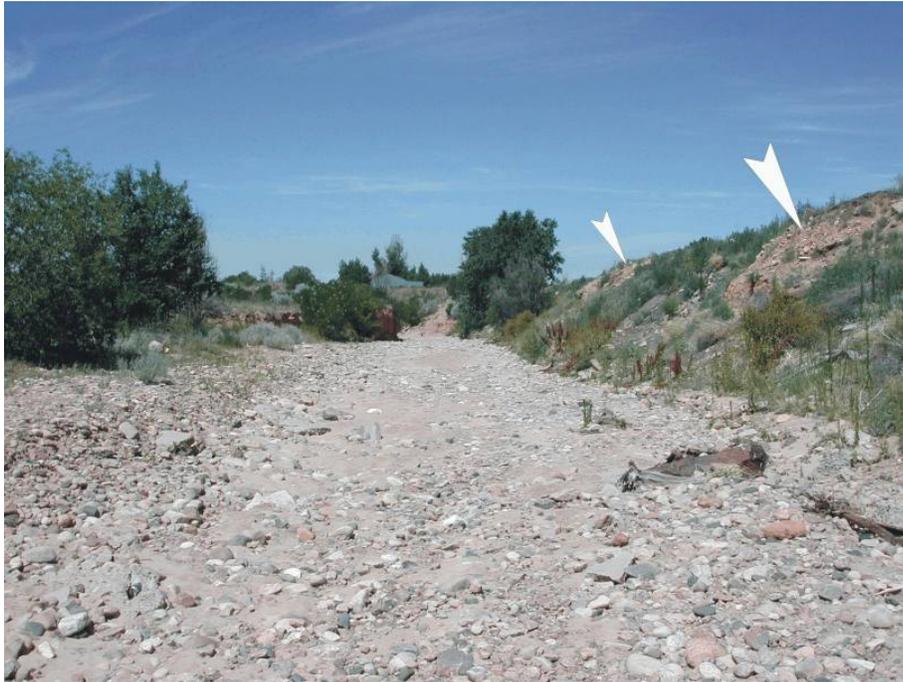
Figure 18. Channel-narrowing fill along right bank in segment SFR-4. View is downstream. Photo by J. Pittenger, 26 June 2007.

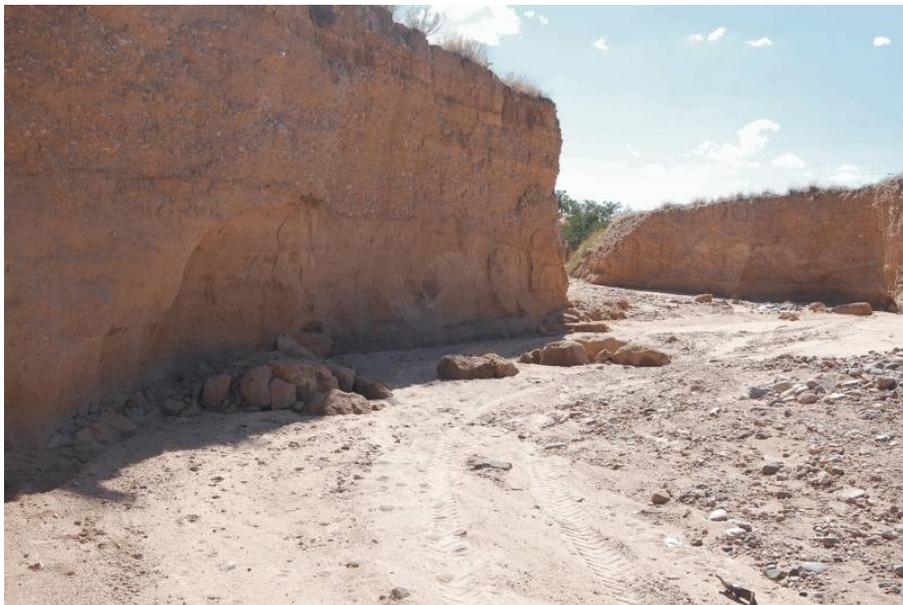
Figure 19. Deeply-entrenched F5 channel below CR 62. View is downstream. Photo by J. Pittenger, 19 September 2007.

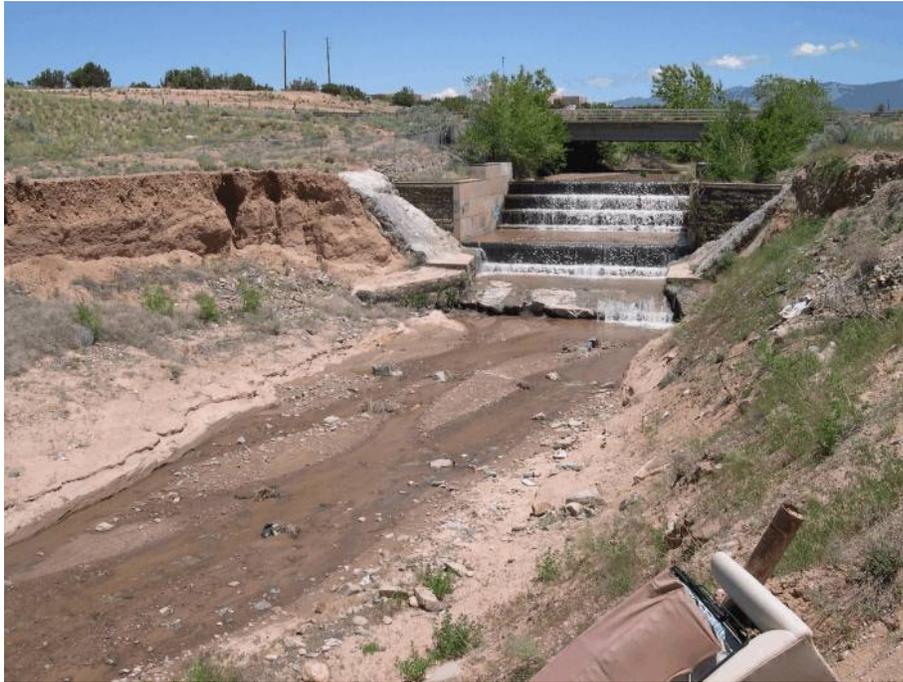
Figure 21. Grade control structure GCS-2 at the CR 62 crossing. View is upstream. Photo by J. Pittenger, 24 May 2007.

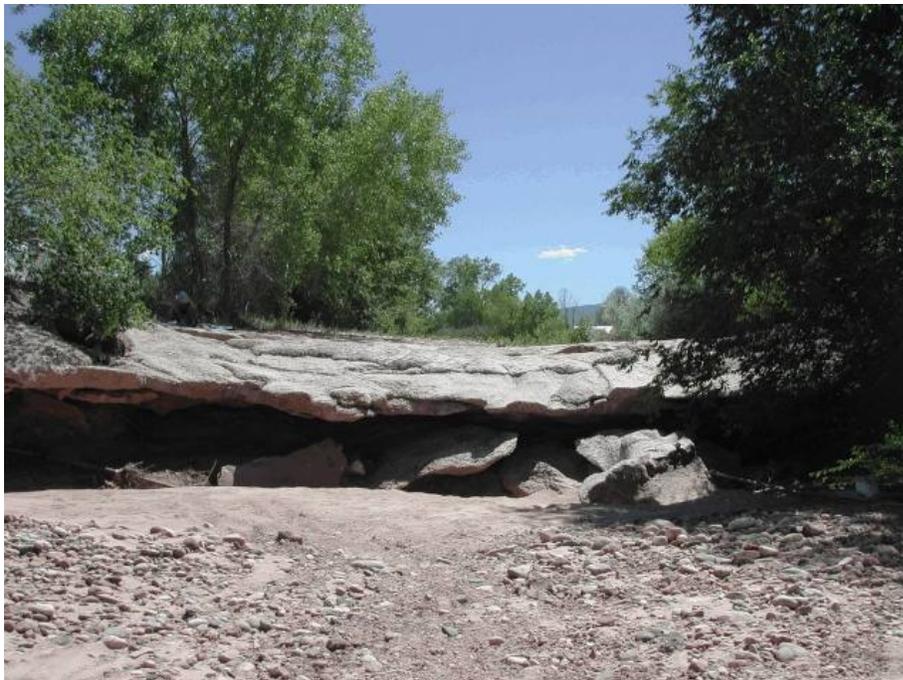
Figure 22. Grade control structure GCS-5 at the Vereda de San Antonio crossing. View is upstream. Photo by J. Pittenger, 26 June 2007.

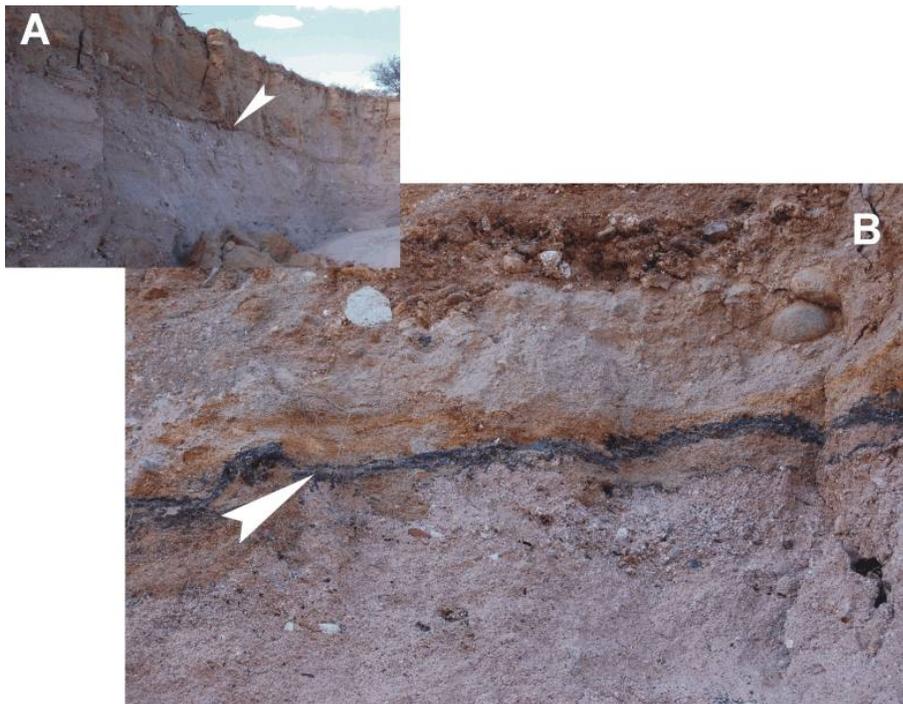
Remnant indicators of hydric soils were found in a vertical cut-bank below CR 62 at Agua Fria during field surveys in 2007. These indicators included a thin organic carbon strata overlaid by a band of iron oxide staining (Figure WET). These features were present in the cut bank about 10 feet above the current channel bed.

Figure 40. Remnant hydric soil indicators in a cut bank below CR 62 at Agua Fria. Inset photo "A" shows the location of the indicator strata about 10 feet above the current channel bed. Photo "B" shows the thin black carbon strata overlaid by iron oxide-stained sediments. Photo by J. Pittenger, 19 September 2007.

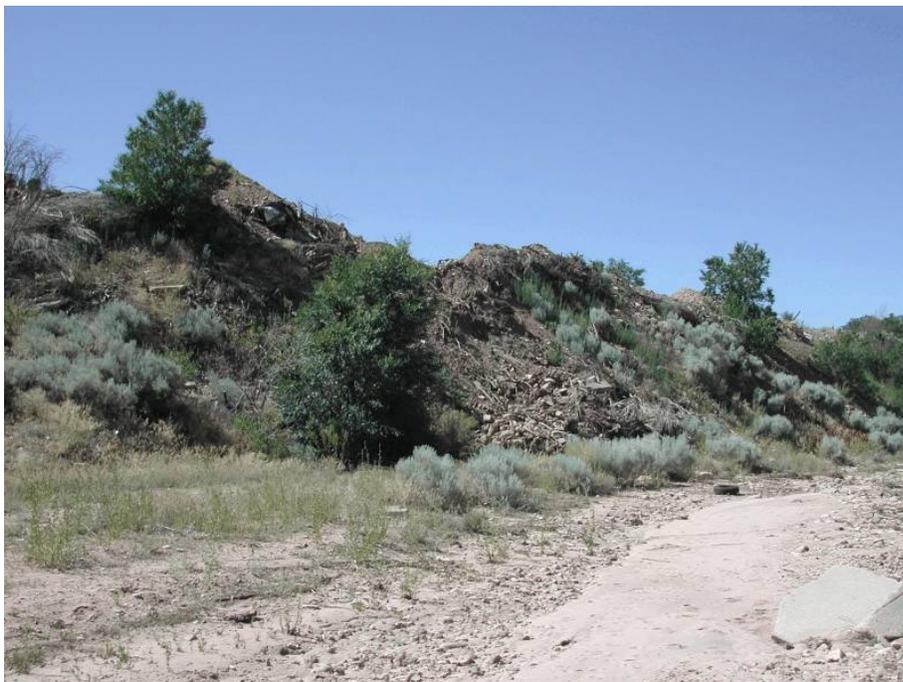
Figure 46. Waste piles spilling into the river channel. View is downstream in the reach below Camino Carlos Rael, 22 June 2007. Photo by J. Pittenger.

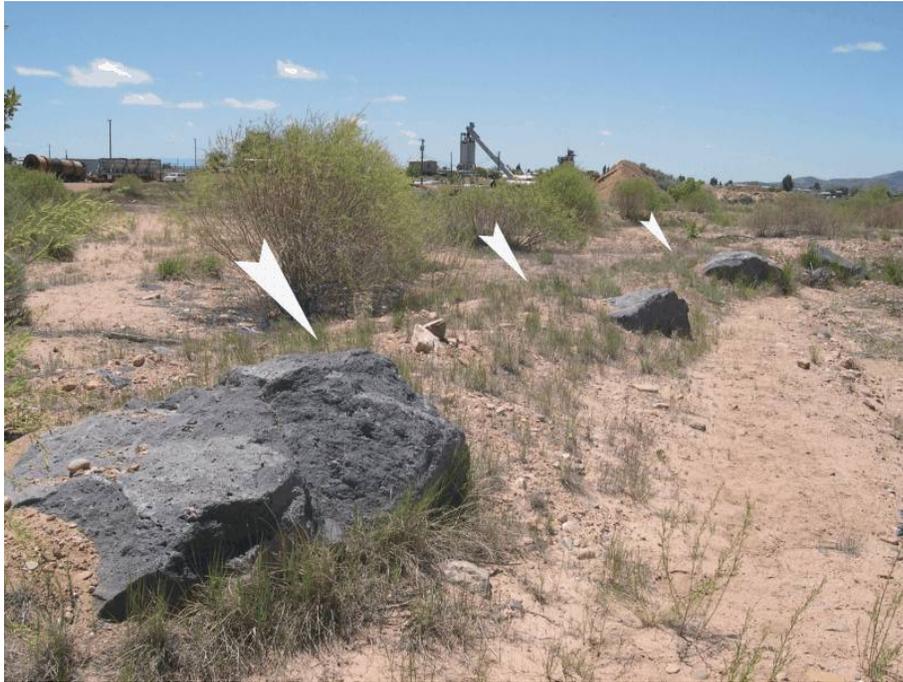
Figure 47. Unauthorized grading plugged the restored meander constructed in 2000 on State Trust land at the downstream end of the study area. Arrows indicate berm that was pushed up to block off the meander from the river. View is downstream. Current river channel bank is to the right of the berm, the restored meander channel, now cut-off from the river, is to the left of the berm. Photo by J. Pittenger, 24 May 2007.

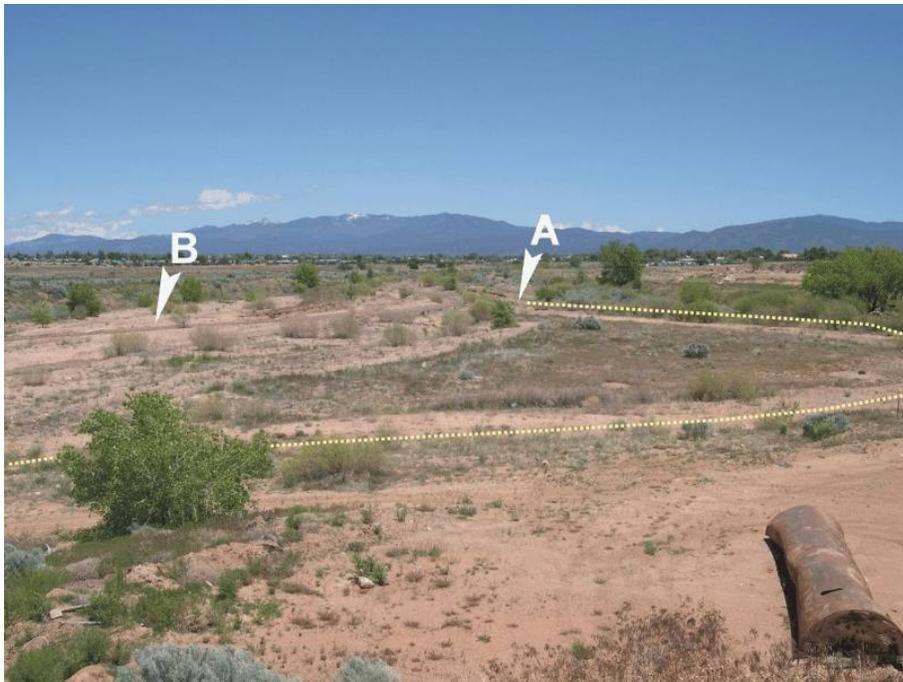
Figure 48. View upstream of the restored meander now isolated from the river. The meander channel is indicated by the dotted line. Arrow "A" shows the location of the channel plug shown in Figure 47. Arrow "B" shows the meander cut-off channel created by unauthorized heavy-equipment grading at the site. View is upstream. Photo by J. Pittenger, 24 May 2007.

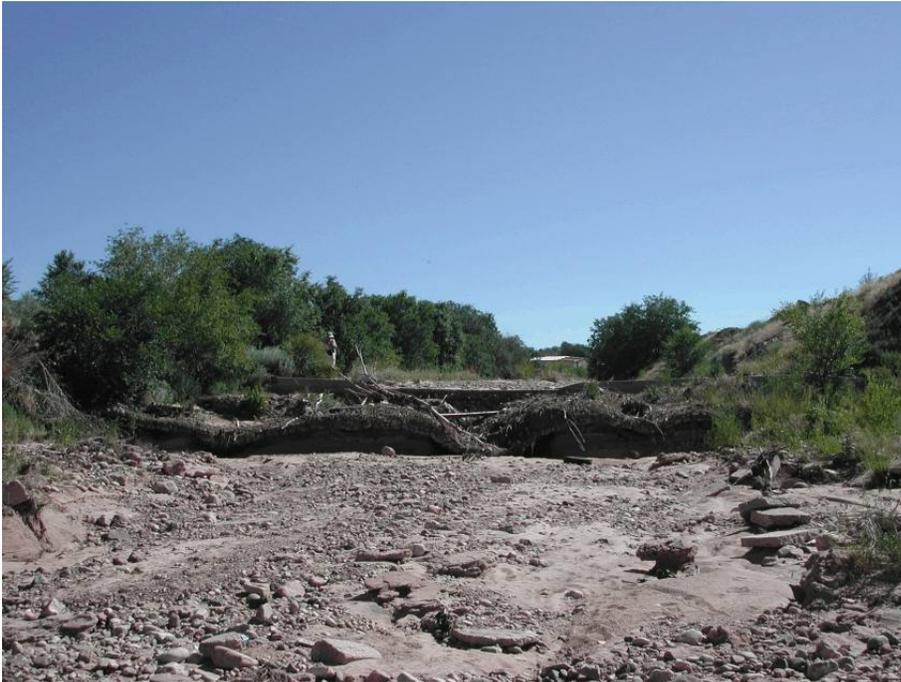
Figure 49. Grade control structure GCS-7, downstream from Camino Carlos Rael, showing failure of the erosion control apron and undermining of the structure. View is upstream. Photo by J. Pittenger, 26 June 2007.
