## SIDEWALK EVALUATION AND METHODOLOGY

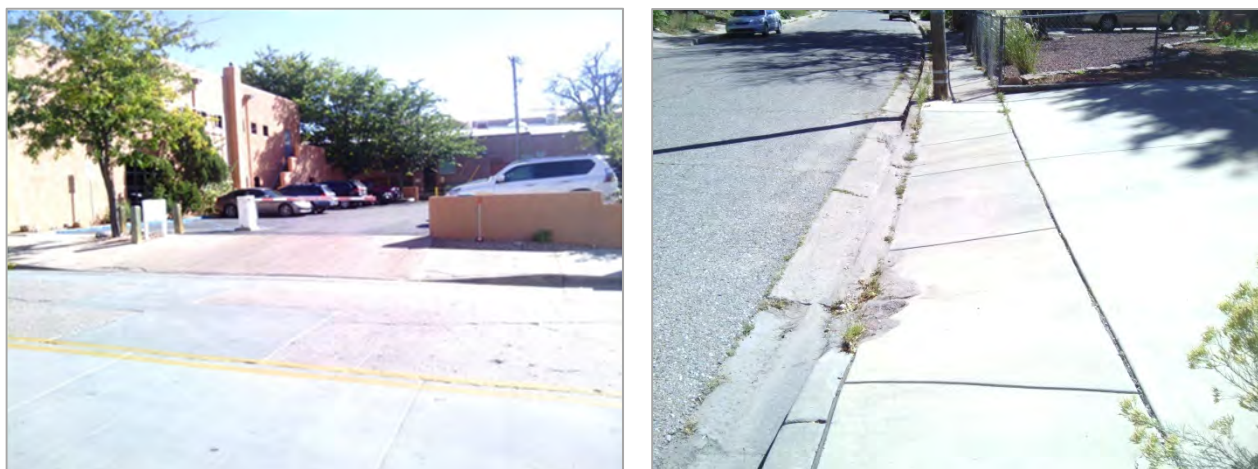
**Figure 2-34: Non-Compliant Driveways**

Survey results revealed that a total of 10,466 driveways in Santa Fe are not currently compliant with ADA guidelines. Figure 2-34 provides two images of non-compliant driveways.

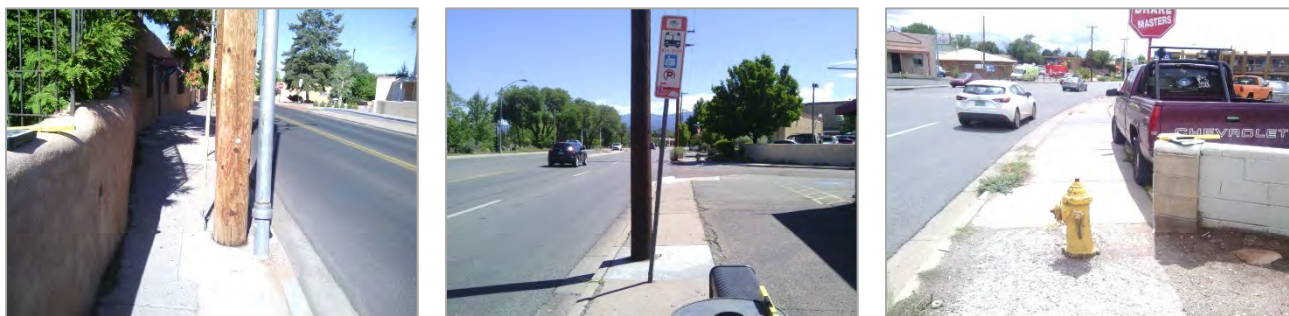
**Figure 2-35: Sidewalk Obstructions**

Obstructions are objects that reduce the walk path to less than 48-inches in width, rendering the walk path unusable to those with mobility impairments. As seen in Table 2-11, common obstructions in Santa Fe include utility poles, street sign poles, and mailboxes. Common sidewalk obstructions are shown in Figure 2-35.

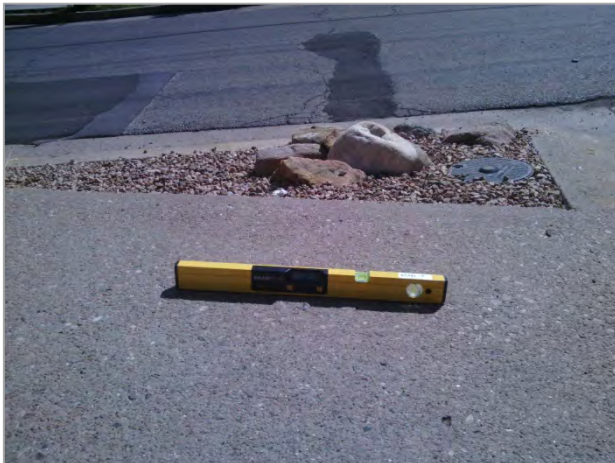
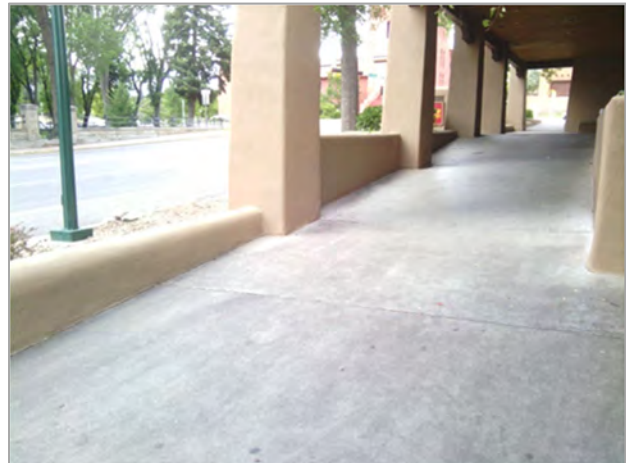
**Figure 2-38: Non-Compliant Running Slopes**

Under ADA guidelines, the sidewalk's running slope is required to match that of the road or not deviated beyond 5% of the road's slope. During the field survey, a total of 220 running slope issues were noted. As seen in Table 2-14, nearly two-thirds of the running slope issues were between 5.1% and 10% with the other third accounting for more severe slopes over 10%. Figure 2-38 shows some examples of running slope deficiencies.
