# Initial Site Assessment

**Cerrillos Road Reconstruction, Phase IIC  
Camino Carlos Rey to Llano Street  
Santa Fe, Santa Fe County, New Mexico  
Control Number: CNS100130**

Terracon Project No. 66137738

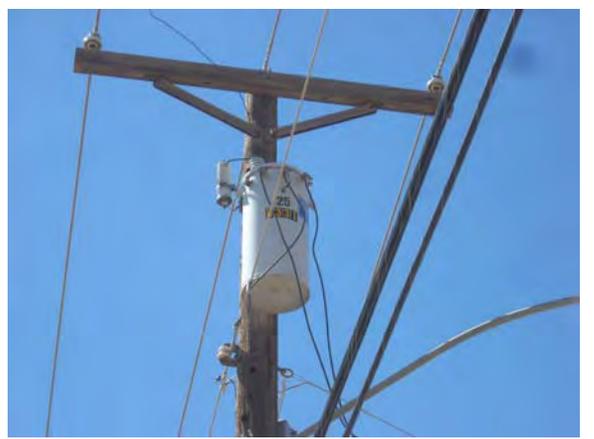
**Photo #6** Typical view of one of five pole-mounted transformers along the northwest side of the Project Corridor.

Five pole-mounted electrical transformers were observed along the northwest side of the Project Corridor. Indications of releases from these transformers were not observed during the site reconnaissance (site reconnaissance, 2013).

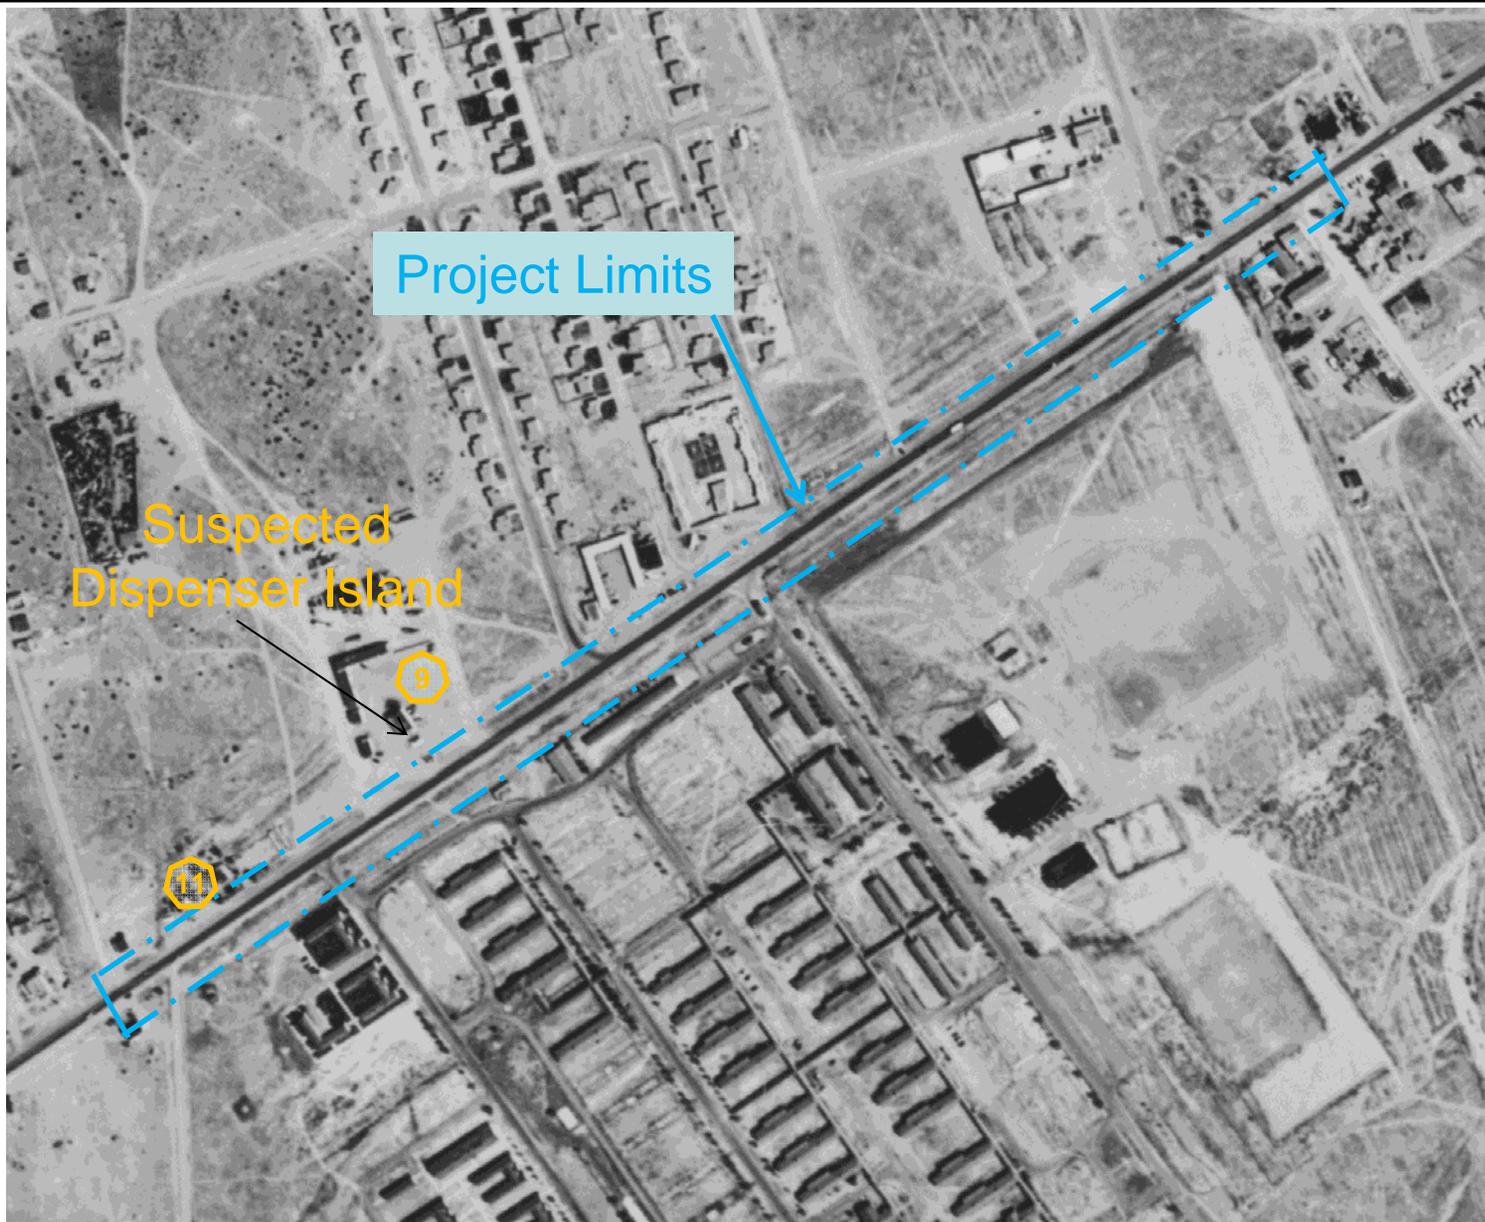
1951 AERIAL PHOTOGRAPH  
CERRILLOS ROAD RECONSTRUCTION, PHASE IIC  
CAMINO CARLOS REY TO LLANO STREET  
SANTA FE, SANTA FE COUNTY, NEW MEXICO

Suspected  
Dispenser Island

9 Recognized Environmental Condition, Finding No. 9 – 2501 Cerrillos Road

Based on the Conclusions of this ISA and the planned disturbance of soils adjacent to the two RECs to over five feet, Terracon recommends an assessment of petroleum hydrocarbon impact to the subsurface soils to the maximum depth of soil disturbance in portions of the Project Corridor adjoining the 2501 Cerrillos Road and 2631 Cerrillos Road. Contaminant concentrations, if present, should be evaluated in the context of worker protection and waste disposal. Terracon also recommends an evaluation of the presence of relic USTs within the ROW adjacent to the historic gas stations located at 2501 Cerrillos Road.

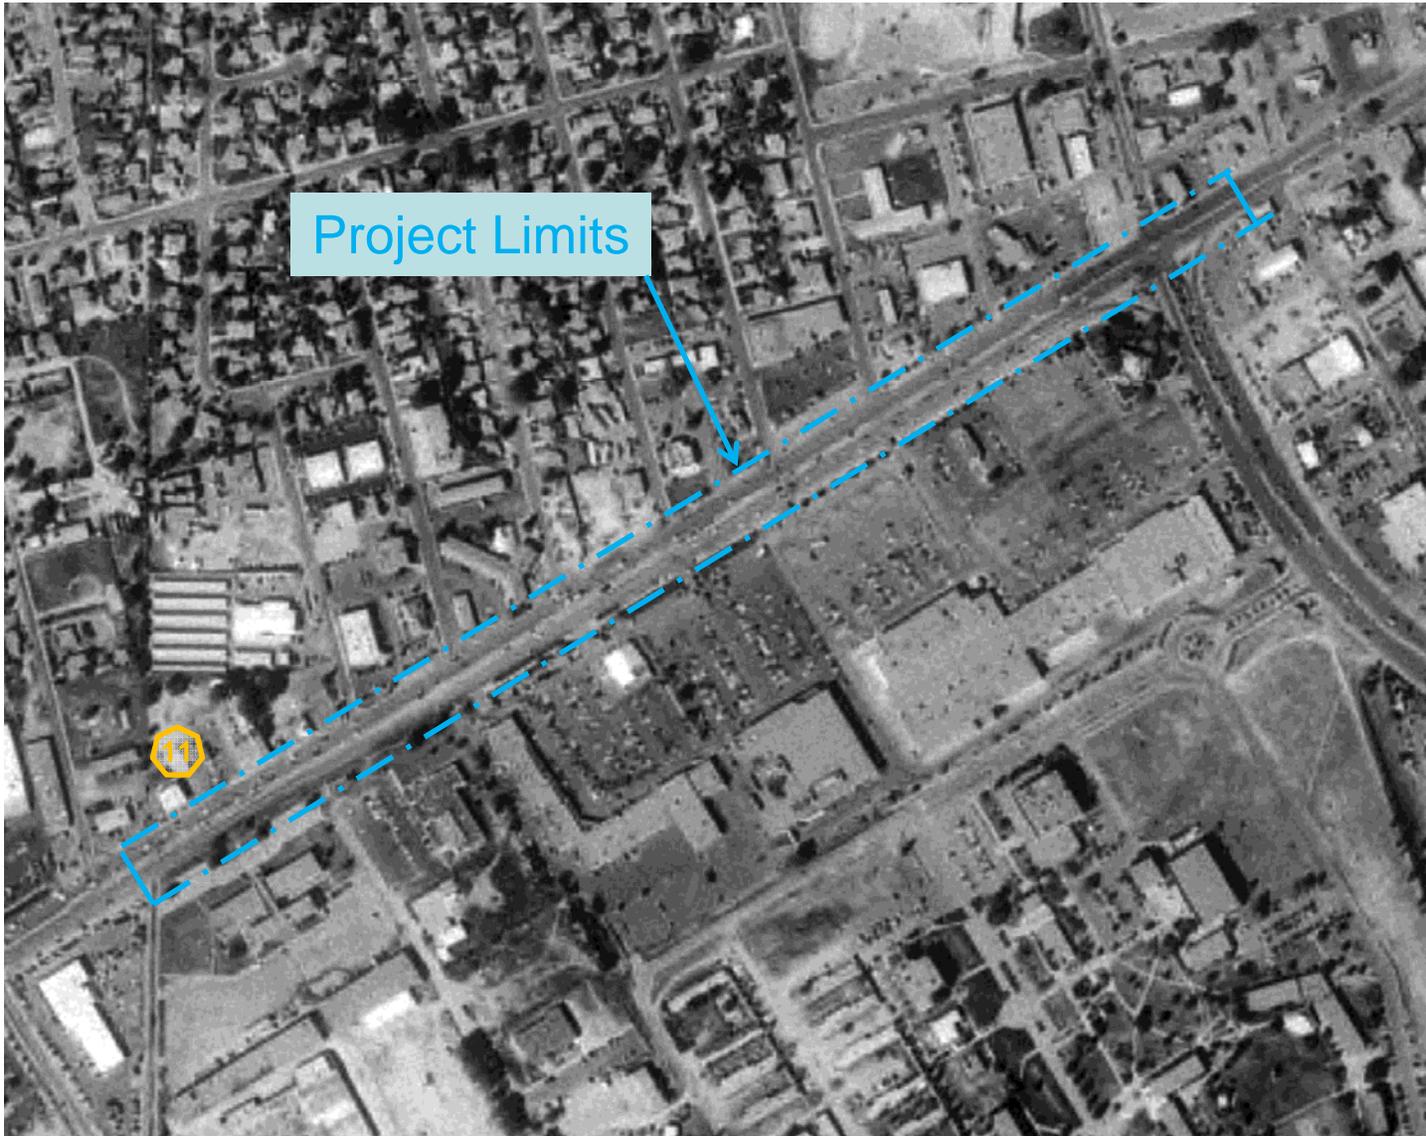
EXHIBIT
<b>8</b>

<b>1987 AERIAL PHOTOGRAPH</b>
CERRILLOS ROAD RECONSTRUCTION, PHASE IIC CAMINO CARLOS REY TO LLANO STREET SANTA FE, SANTA FE COUNTY, NEW MEXICO

Recognized Environmental Condition, Finding No. 11 – 2631 Cerrillos Road

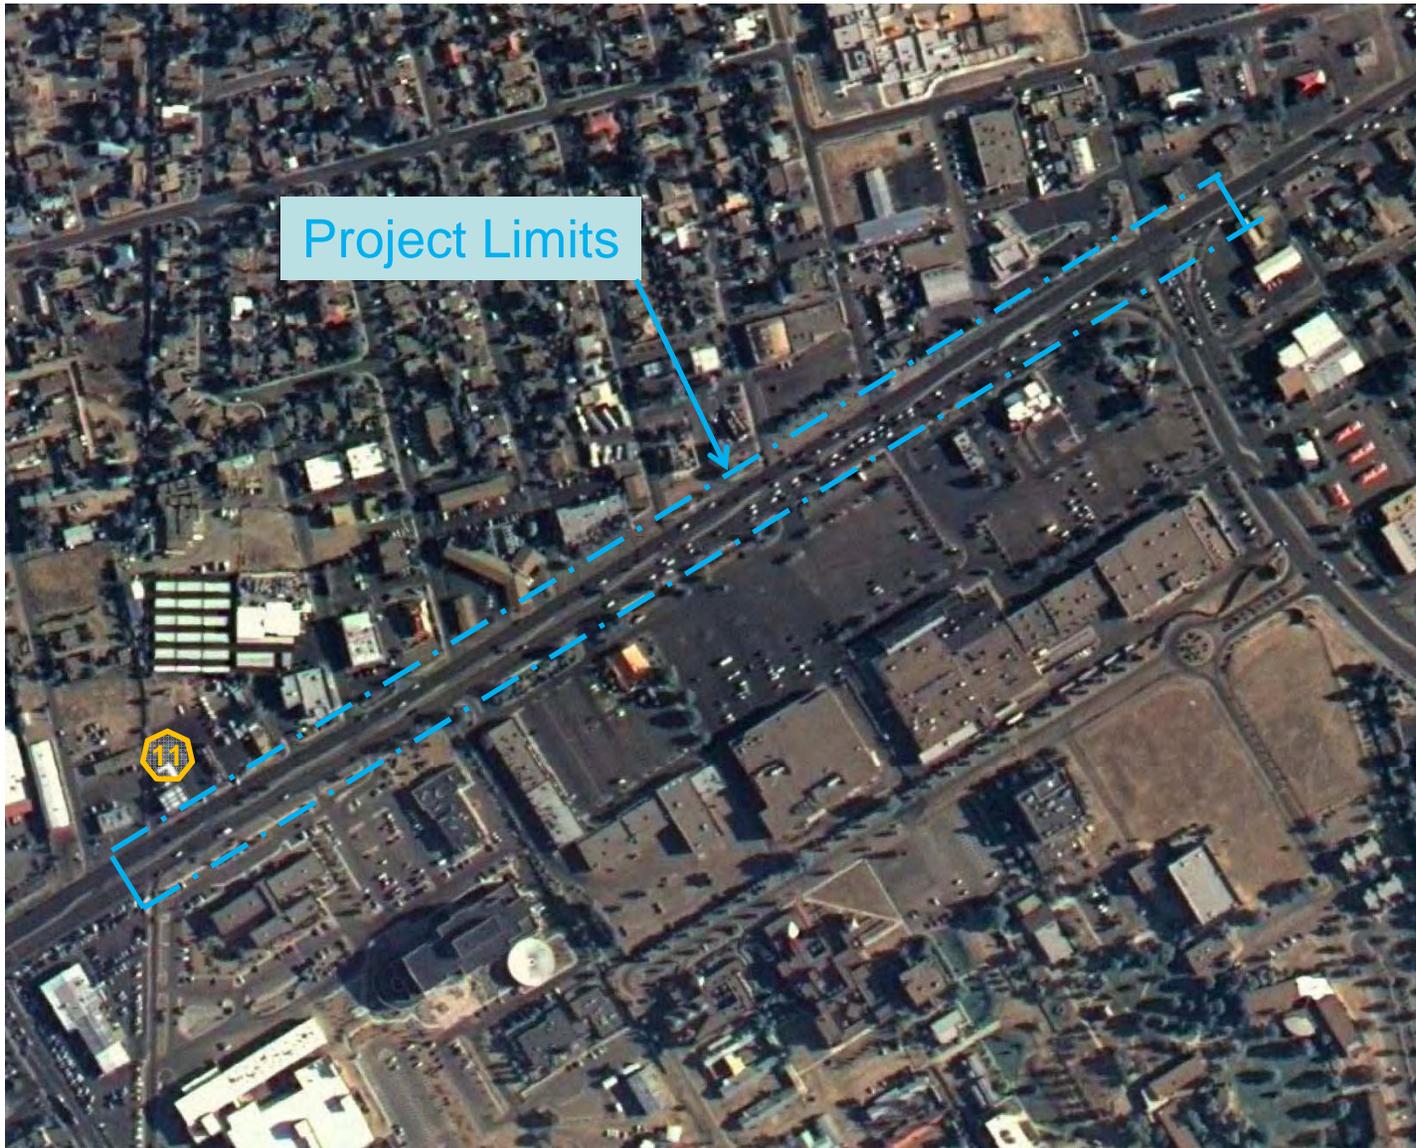
Recognized Environmental Condition, Finding No. 9 – 2501 Cerrillos Road

Based on the Conclusions of this ISA and the planned disturbance of soils adjacent to the two RECs to over five feet, Terracon recommends an assessment of petroleum hydrocarbon impact to the subsurface soils to the maximum depth of soil disturbance in portions of the Project Corridor adjoining the 2501 Cerrillos Road and 2631 Cerrillos Road. Contaminant concentrations, if present, should be evaluated in the context of worker protection and waste disposal. Terracon also recommends an evaluation of the presence of relic USTs within the ROW adjacent to the historic gas stations located at 2501 Cerrillos Road.
